AMD Duron™ Processor Model 3

Revision Guide

AMD Duron™ Processor Model 3 Revision Guide

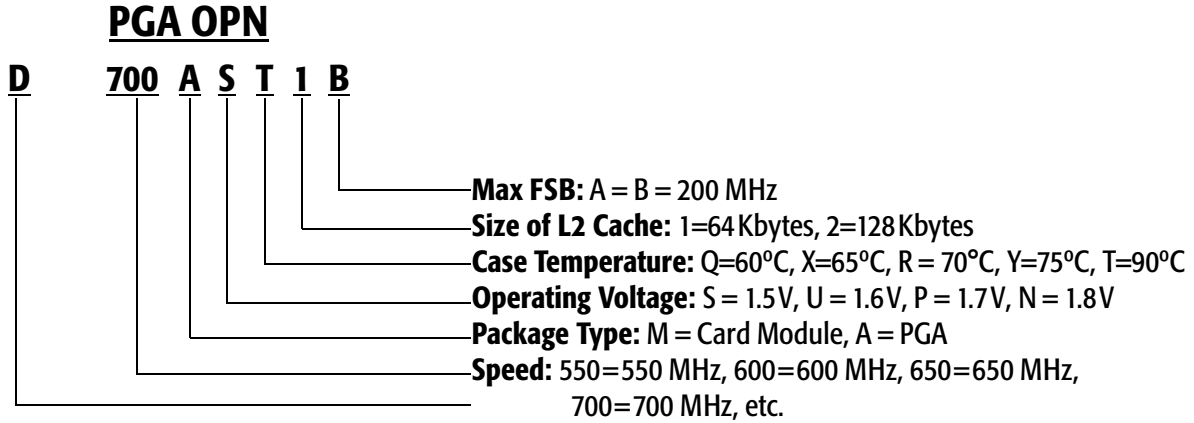
1.1 Production Marking

Note: Spaces are added to the number shown above for viewing clarity only.

Family/Architecture: D = AMD Duron™ Processor Model 3 Architecture
